ABS MWO FIELD SERVICE BULLETIN

Several M939/A1/A2 series trucks have been found with improper installation of the M939 ABS MWO 9-2320-272-35-1. These instructions contain a method for inspection of the vehicles to identify whether the air supply hose installation is not correct and procedures to correct the installation.

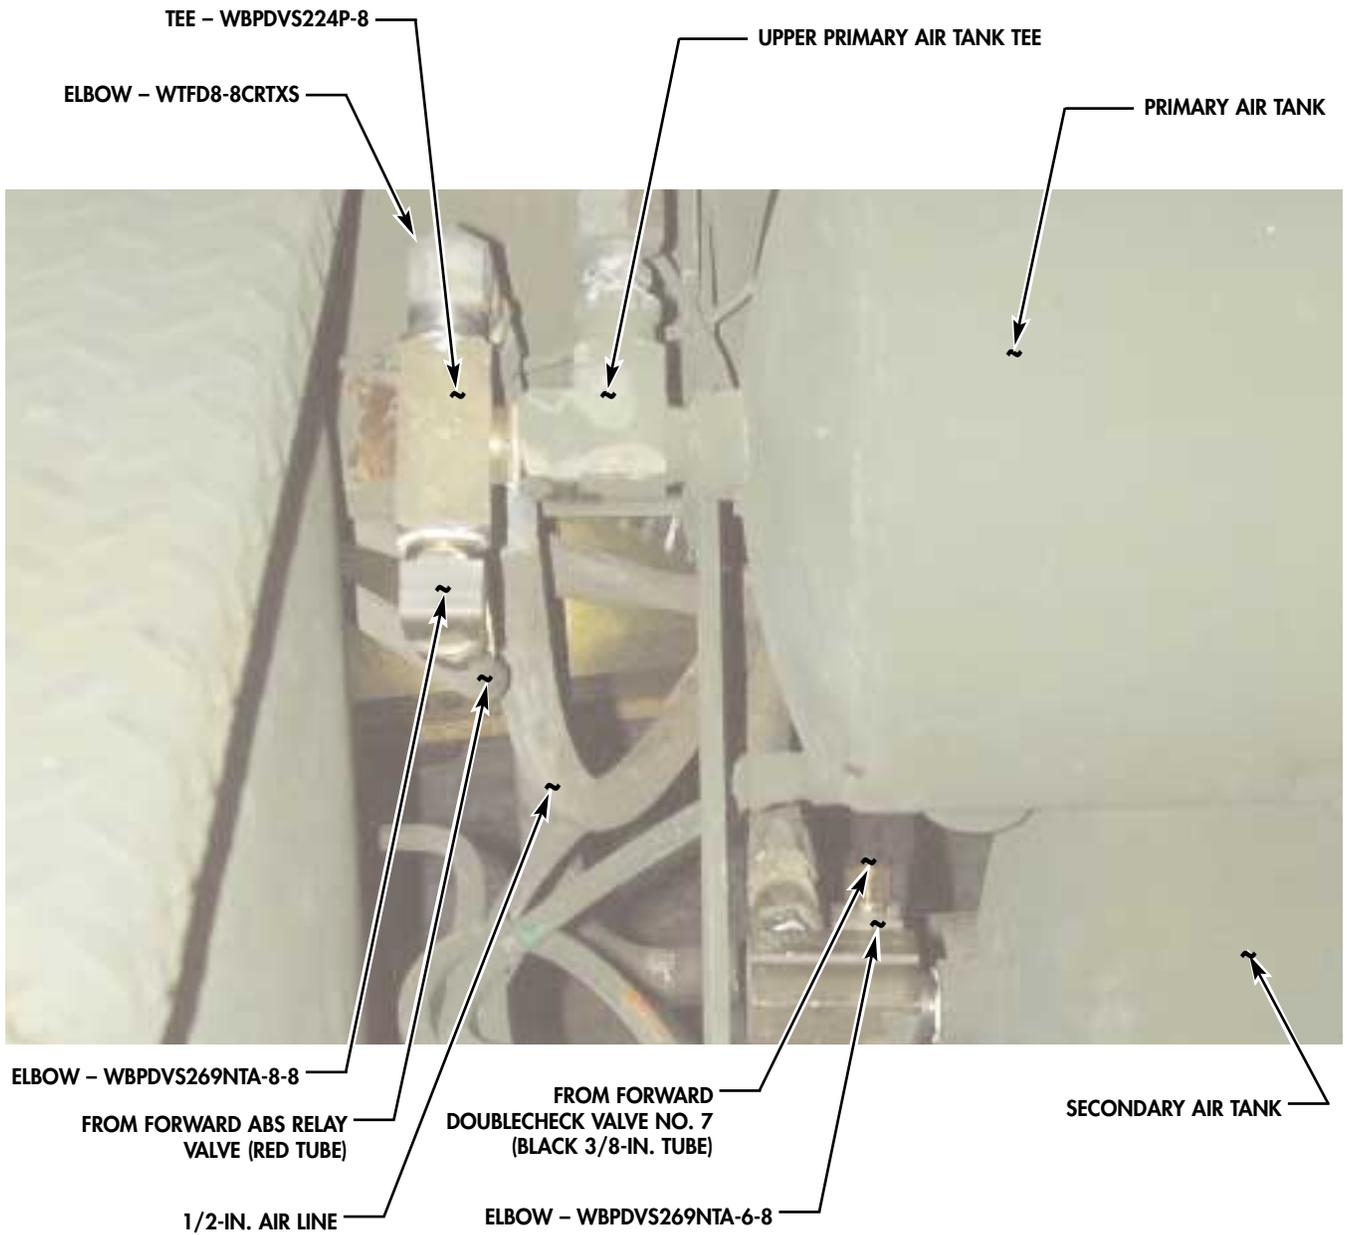
FIGURE 1. CORRECT (VIEWED FROM TOP)

(1) Red hose from forward ABS relay valve should be connected to upper primary air tank tee (uppermost tank).

NOTE: ALL M939 BASIC AND A1 MODELS (EXCEPT WRECKER AND XLWB CARGO TRUCKS).

a. Install elbow WBPDVS269NTA-8-8, elbow WTFD8-8CRTXS, and tee WBPDVS224P-8 onto upper primary air tank tee as shown in figure 1.

b. Connect 1/2-in. air line to elbow WTFD8-8CRTXS and connect red tube to elbow WBPDVS269NTA-8-8 as shown in figure 1.

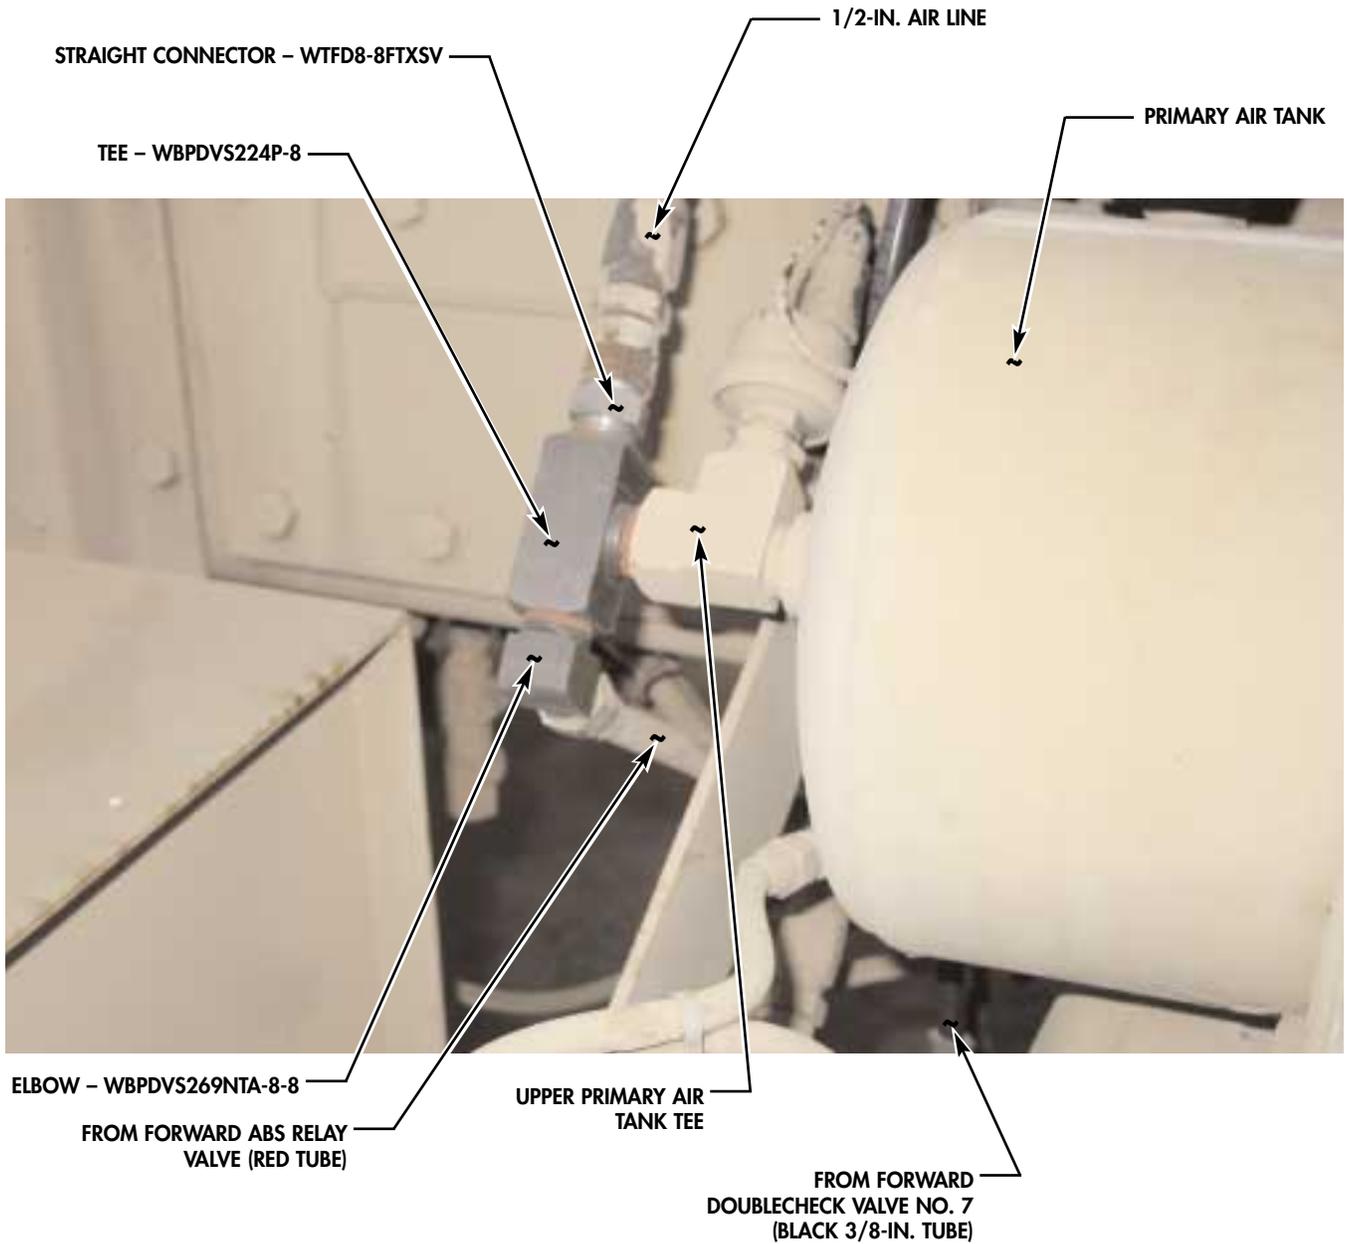
FIGURE 2. CORRECT (VIEWED FROM TOP)

NOTE: ALL M939A2 MODELS. ALL WRECKER MODELS. ALL CARGO TRUCKS WITH EXTRA-LONG WHEELBASE.

c. Install elbow WBPDVS269NTA-8-8, straight connector WTFD8-8FTXSV, and tee WBPDVS224P-8 onto upper primary air tank tee as shown in figure 2.

d. Connect 1/2-in. air line to straight connector WTFD8-8FTXSV and connect red tube to elbow WBPDVS269NTA-8-8 as shown in figure 2.

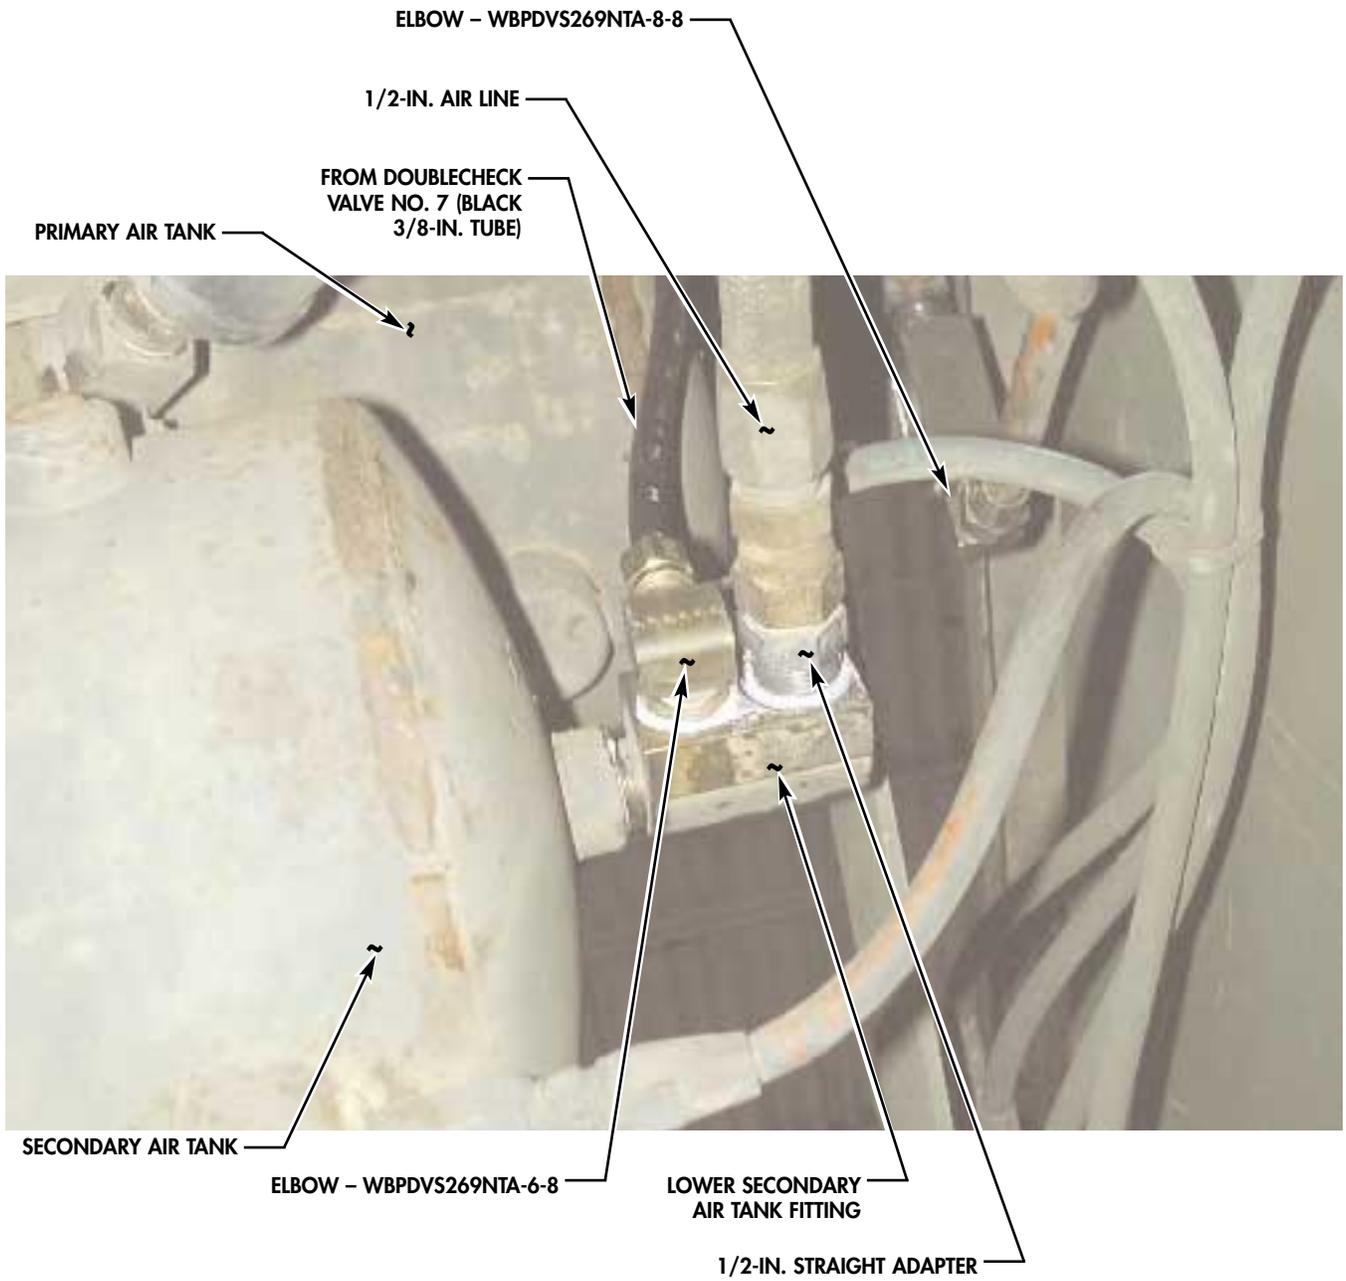
FIGURE 3. CORRECT (VIEWED FROM BOTTOM)

(2) Black tube from doublecheck valve No. 7 should be connected to lower secondary air tank fitting.

e. Install elbow WBPDVS269NTA-6-8 on lower secondary air tank fitting as shown in figure 3.

f. Install 1/2-in. straight adapter on lower secondary air tank fitting as shown in figure 3.

g. Connect black 3/8-in. tube to elbow WBPDVS269NTA-6-8 on lower secondary air tank fitting as shown in figure 3.

h. Connect 1/2-in. air line to 1/2-in. straight adapter on lower secondary air tank fitting as shown in figure 3.

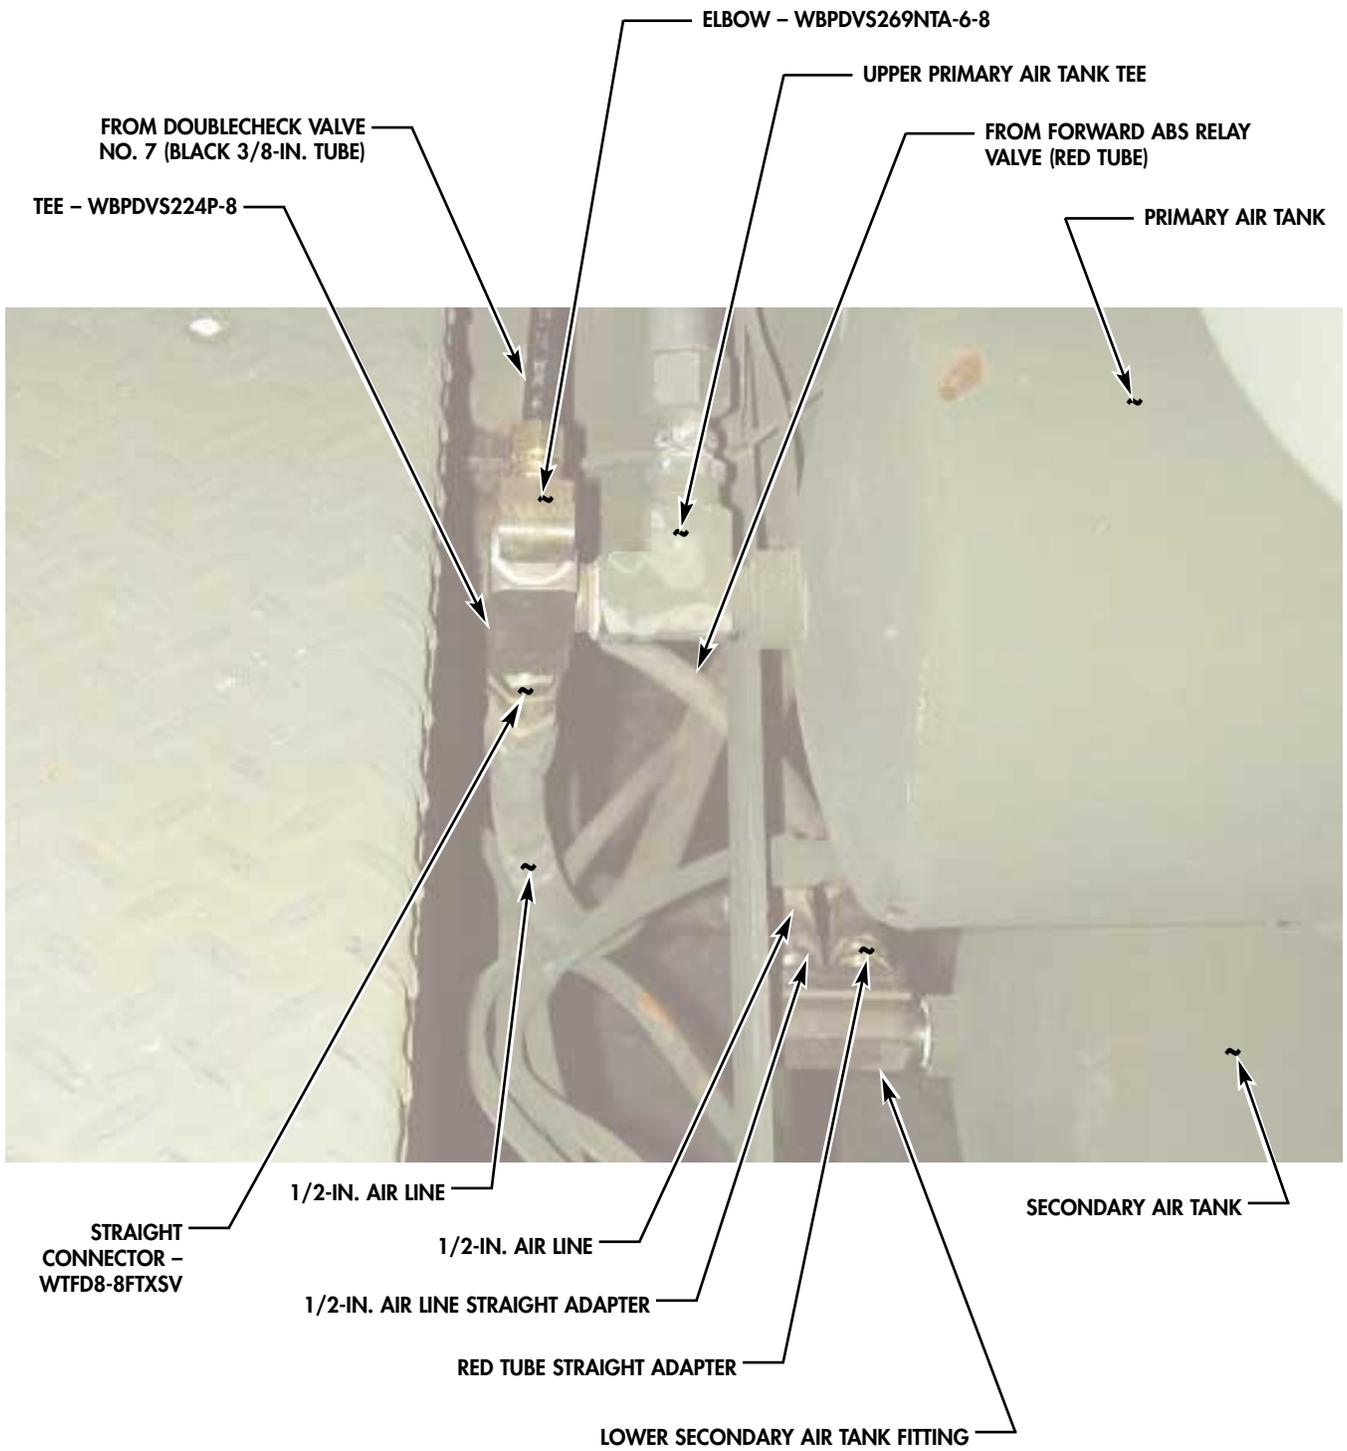
FIGURE 4. INCORRECT (VIEWED FROM TOP)

(3) If red and black tubes are in correct locations (figures 1, 2, and 3), no further action is required. If red and black tubes are not in correct position (figure 4), proceed to disassembly.

- a. Drain all air reservoirs.
- b. Disconnect red tube and remove red tube straight adapter from lower secondary air tank fitting (figure 4). Discard adapter.
- c. Disconnect 1/2-in. air line and remove 1/2-in. air line straight adapter from lower secondary air tank fitting (figure 4). Retain adapter.
- d. Disconnect black 3/8-in. tube and 1/2-in. air line from primary air tank tee (figure 4).
- e. Remove tee WBPDV224P-8 with attached fittings from upper primary air tank tee. Remove elbow WBPDV269NTA-6-8 and straight connector WTFD8-8FTXS from tee (figure 4). Retain elbow, connector, and tee.
